LOWER HOUSATONIC RIVER BASIN
TORRINGTON , CONNECTICUT

CRYSTAL LAKE DAM
CT - 00097

PHASE I INSPECTION REPORT
NATIONAL DAM INSPECTION PROGRAM

FEBRUARY 1980

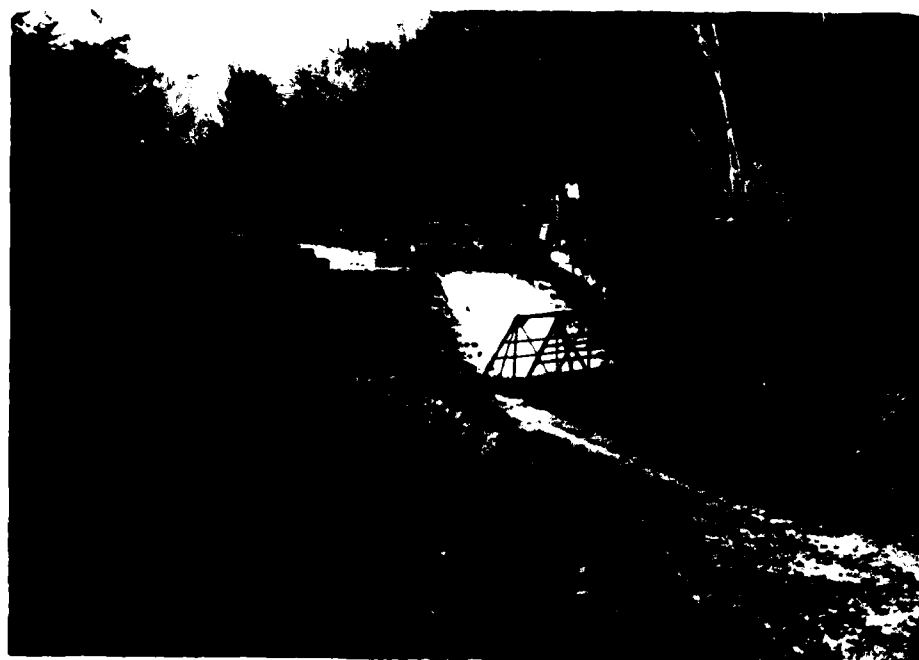
PHOTO #2: Downstream face of dam from right (south) side.

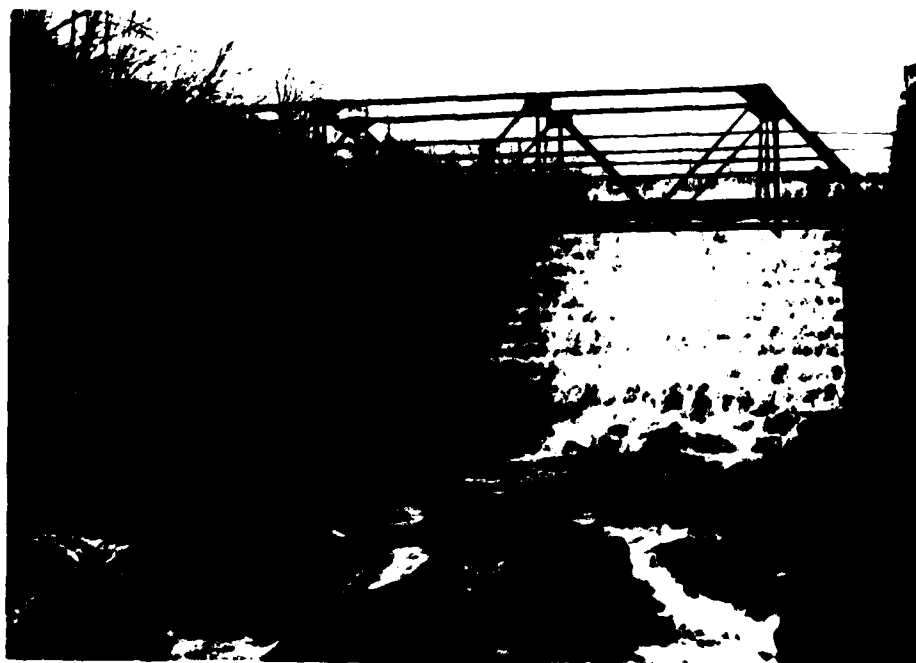
4) Spillway - The visible portions of the stone spillway are in good condition (Photo No. 4) with no significant faults. The left (north) side of the spillway's face was not visible due to the discharge over it. The stone and mortar spillway training walls are in good condition, as indicated in Photo No. 6 and Photo No. 9.

PHOTO #4: Spillway and service bridge.

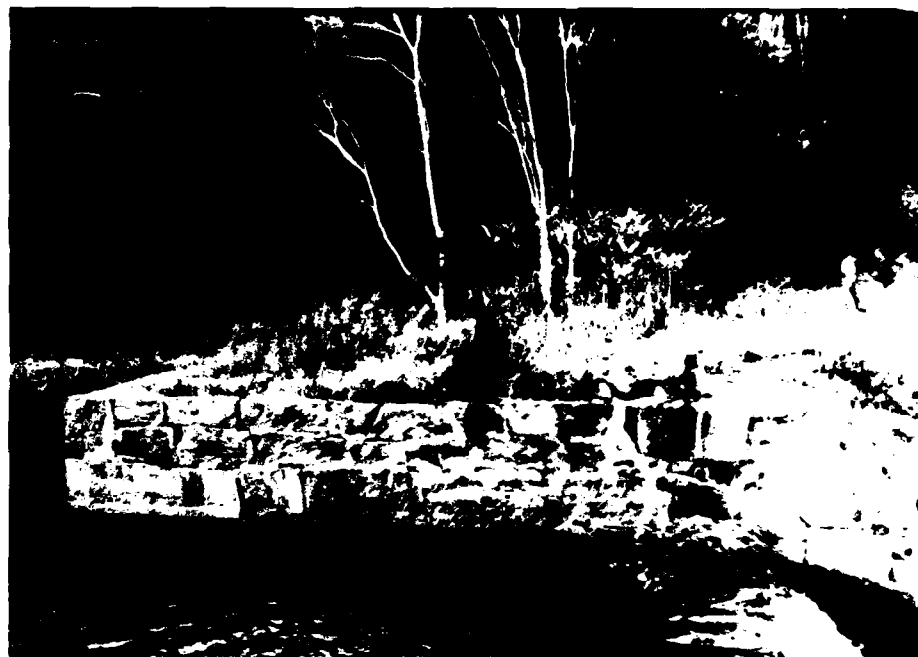
2) Crest - The crest is covered with vegetation, as indicated in Photo No. 3 and Photo No. 5. A portion of the concrete core wall was exposed on the left (north) side of the dam (see Photo No. 11). An area on the crest has been worn bare as a result of trespassing and vehicular traffic, as indicated in Photo No. 3.

c. Appurtenant Structures. There is an 18 inch diameter conduit under the north side of the dam. The valve stem was observed at the top of the dam (see Photo No. 5) north of the spillway. The conduit's outlet is through a stone wall on the downstream side of the dam. Some deterioration of the pipe was noted. The blow off is reported to be opened and exercised about once every two to three years.

PHOTO #5: Crest of dam, looking toward left (north) abutment.

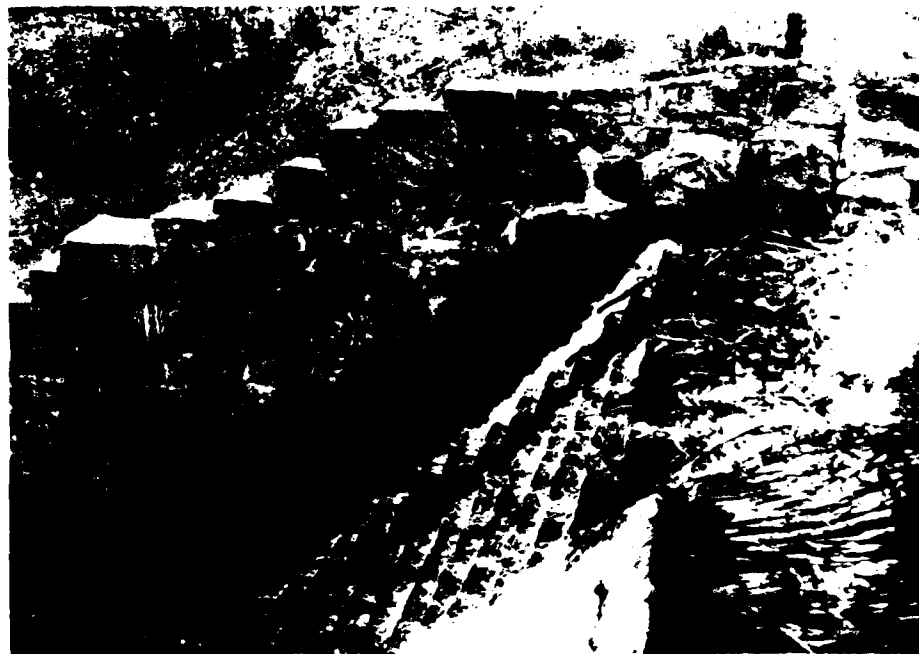
PHOTO #9: Right (south) spillway training wall.

3) Repair displaced masonry blocks in spillway training wall.

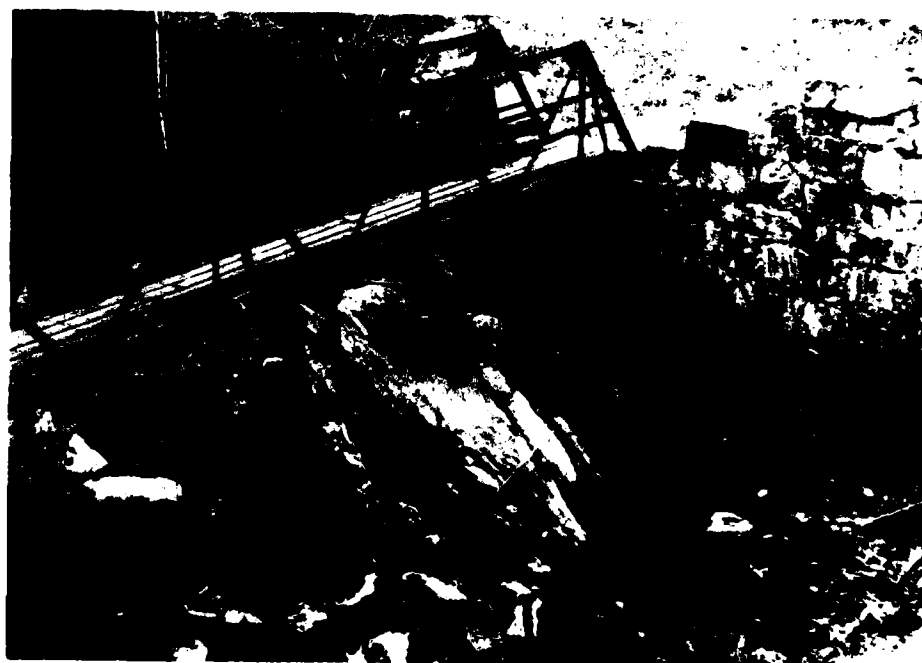
f. Footbridge. The metal truss footbridge over the channel just downstream of the dam has a wood deck and is in good condition, as indicated in Photo No. 10.

PHOTO #10: Spillway channel. Note ledge at bottom.
